Quality Control and Diagnostic Image Integrity In Radiography; an Evaluation of Some Selected Diagnostic Centers In Zaria Nigeria

ABSTRACT

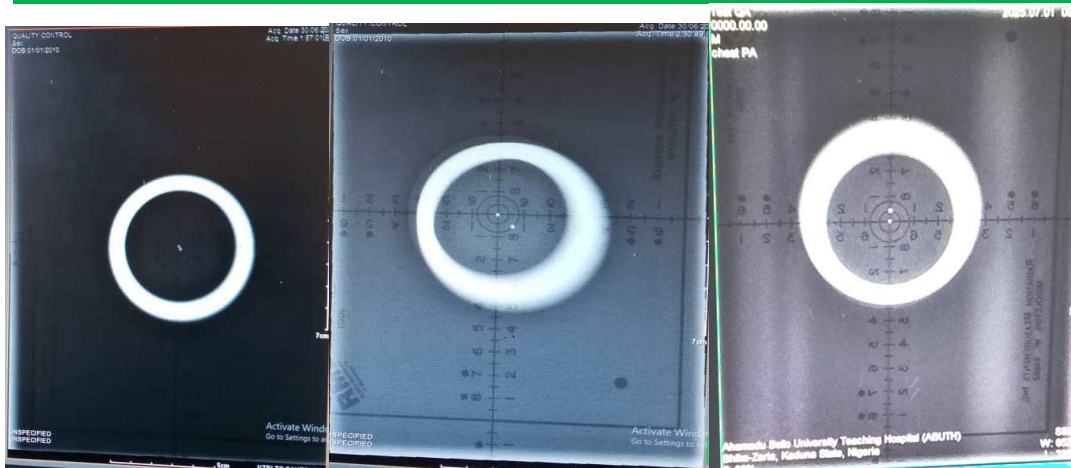
Figure 4: Radiograph of X-ray light beam alignment and centering

Beam alignment and collimation tests were successfully performed on Machine M2 and M3 (Table 4). Due to unstable exposure settings, Machine 1 could not undergo collimation testing, although beam alignment was assessable. Machine 2 and 3 showed alignment deviations within acceptable limits (1cm or 3°) and collimation errors below 2 cm ($\leq 2\%$), consistent with international standards. The highest recorded deviation was 1.2 cm in Machine 2 and 2.0 cm in Machine 3 (Figure 4).

Beam alignment and collimation results indicated satisfactory performance across all testable units. Alignment for all machines were below 1cm (1% at 100 cm FFD), consistent with international tolerance (IAEA, 2023). Collimation deviations for M2 (1.2 cm) and M3 (2 cm) were within the 2% limit, suggesting adequate congruence between the X-ray field and light field. These findings align with reports of Sezdi (2011) and Umaru *et al.*, (2020), who observed similar results. Proper beam alignment and collimation are critical for patient protection, ensuring that only target anatomy is irradiated, and unnecessary exposure is minimized (Saidu *et al.*, 2020). However, M1 could not complete the collimation test due to noise and unstable exposure output, suggesting severe performance degradation that warrants immediate technical intervention. The HVL result confirmed this pattern. Machines M2 (3.0 mm Al) and M3 (2.9 mm Al) met the expected filtration levels for 70kVp (Mamma *et al.*, 2023). While M1 showed a lower HVL (1.55mmAl), indicating poor beam quality and inadequate filtration. Insufficient filtration allows more low energy photons to reach the patient, increasing skin dose and reducing image contrast (Nouchi *et al.*, 2023; Ike-ogbonna *et al.*, 2020). Difference in HVL performance reflect variations in machines design, filtration materials and maintenance practice (Sezdi, 2011; Ngoye *et al.*, 2022). Taken together, these findings show that only two of the three machines operated within acceptable QC limits, the results highlight how irregular maintenance and calibration contribute to poor machine performance. This reinforces the urgent need for structured QC programs supported by preventive maintenance schedules, dedicated budgets, and technical oversight (Ike-ogbonna *et al.*, 2020; Misokefalou *et al.*, 2022). Establishing regional or national QC monitoring ideally under regulatory supervision would help standards and strengthen compliance across facilities. This study was limited to functional X-ray units in two major public hospitals, which were selected because they serve as the main referral and training centers in the region and account for the majority of radiographic workload. Therefore, the findings may not represent all diagnostic facilities in the region. Nonetheless, they provide valuable baseline data for improving QC practice in similar settings. Future studies should expand to include private facilities and assess trends over time to better inform equipment management policies.

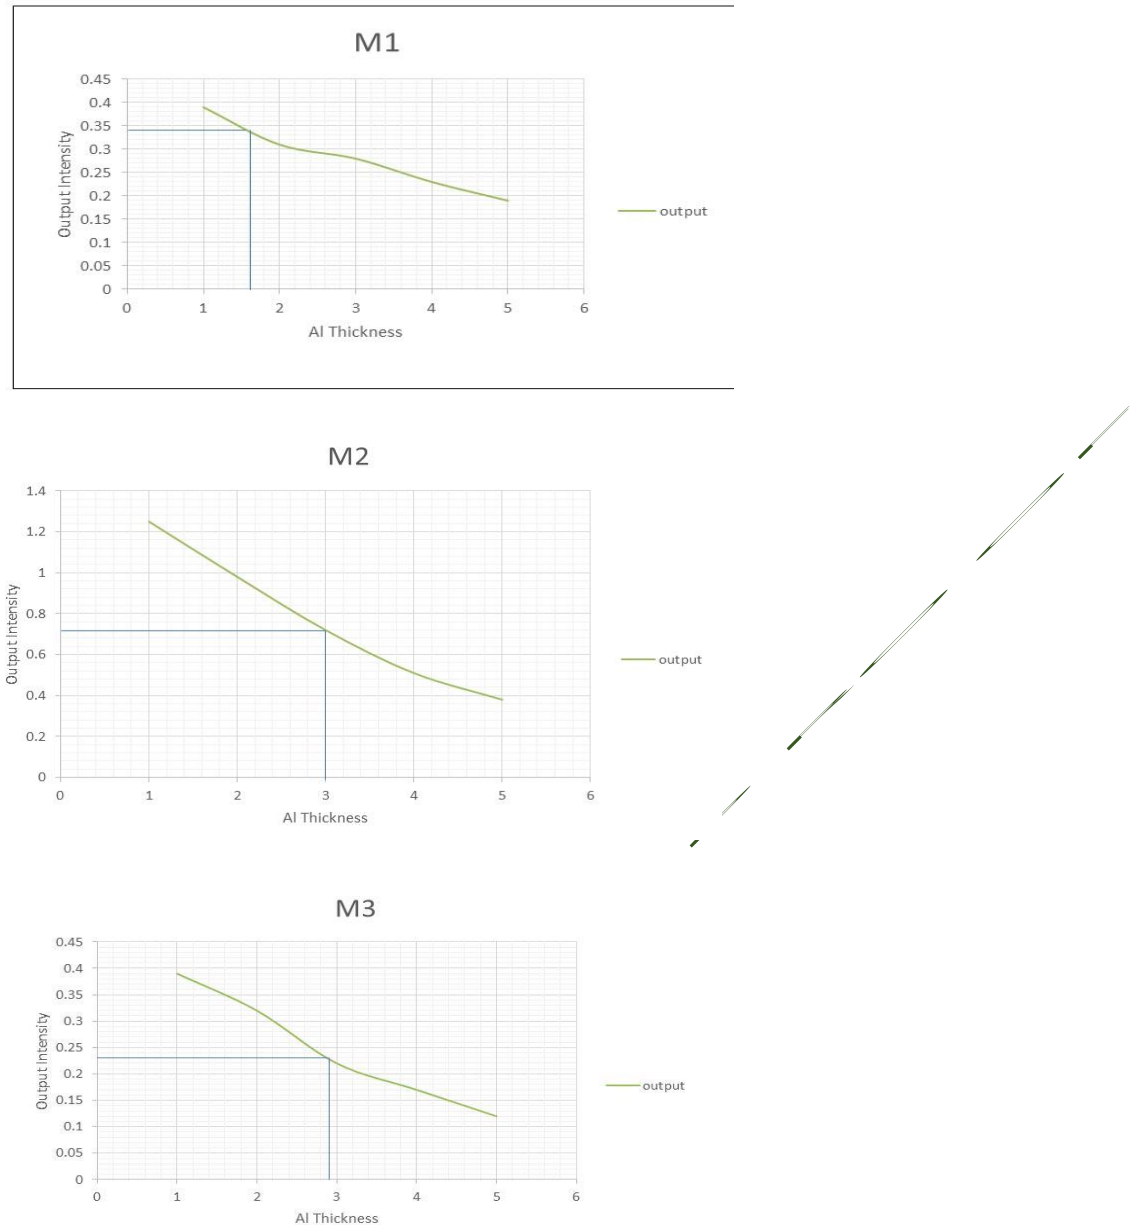
Figure 5: Line Graph for Half Value Layer of the machines

HVL measurements were obtained using incremental aluminum filters (1–5 mm) at 70 kVp and 30 mAs. As the filter thickness increased, the dose decreased progressively (Table 5). The HVL was determined as 1.55 mmAl for Machine 1, 3.0 mmAl for Machine 2, and 2.9 mmAl for Machine 3. Machines 2 and 3 produced harder (better filtered) X-ray beams, while the lower HVL of machine 1 suggested inadequate inherent filtration and suboptimal beam quality (Figure 5).
